PRESTRESSED CONCRETE TEE BEAMS WITH  
LARGE WEB OPENINGS

A THESIS

DEPARTMENT OF CIVIL ENGINEERING  
EDMONTON, ALBERTA

FALL, 1970

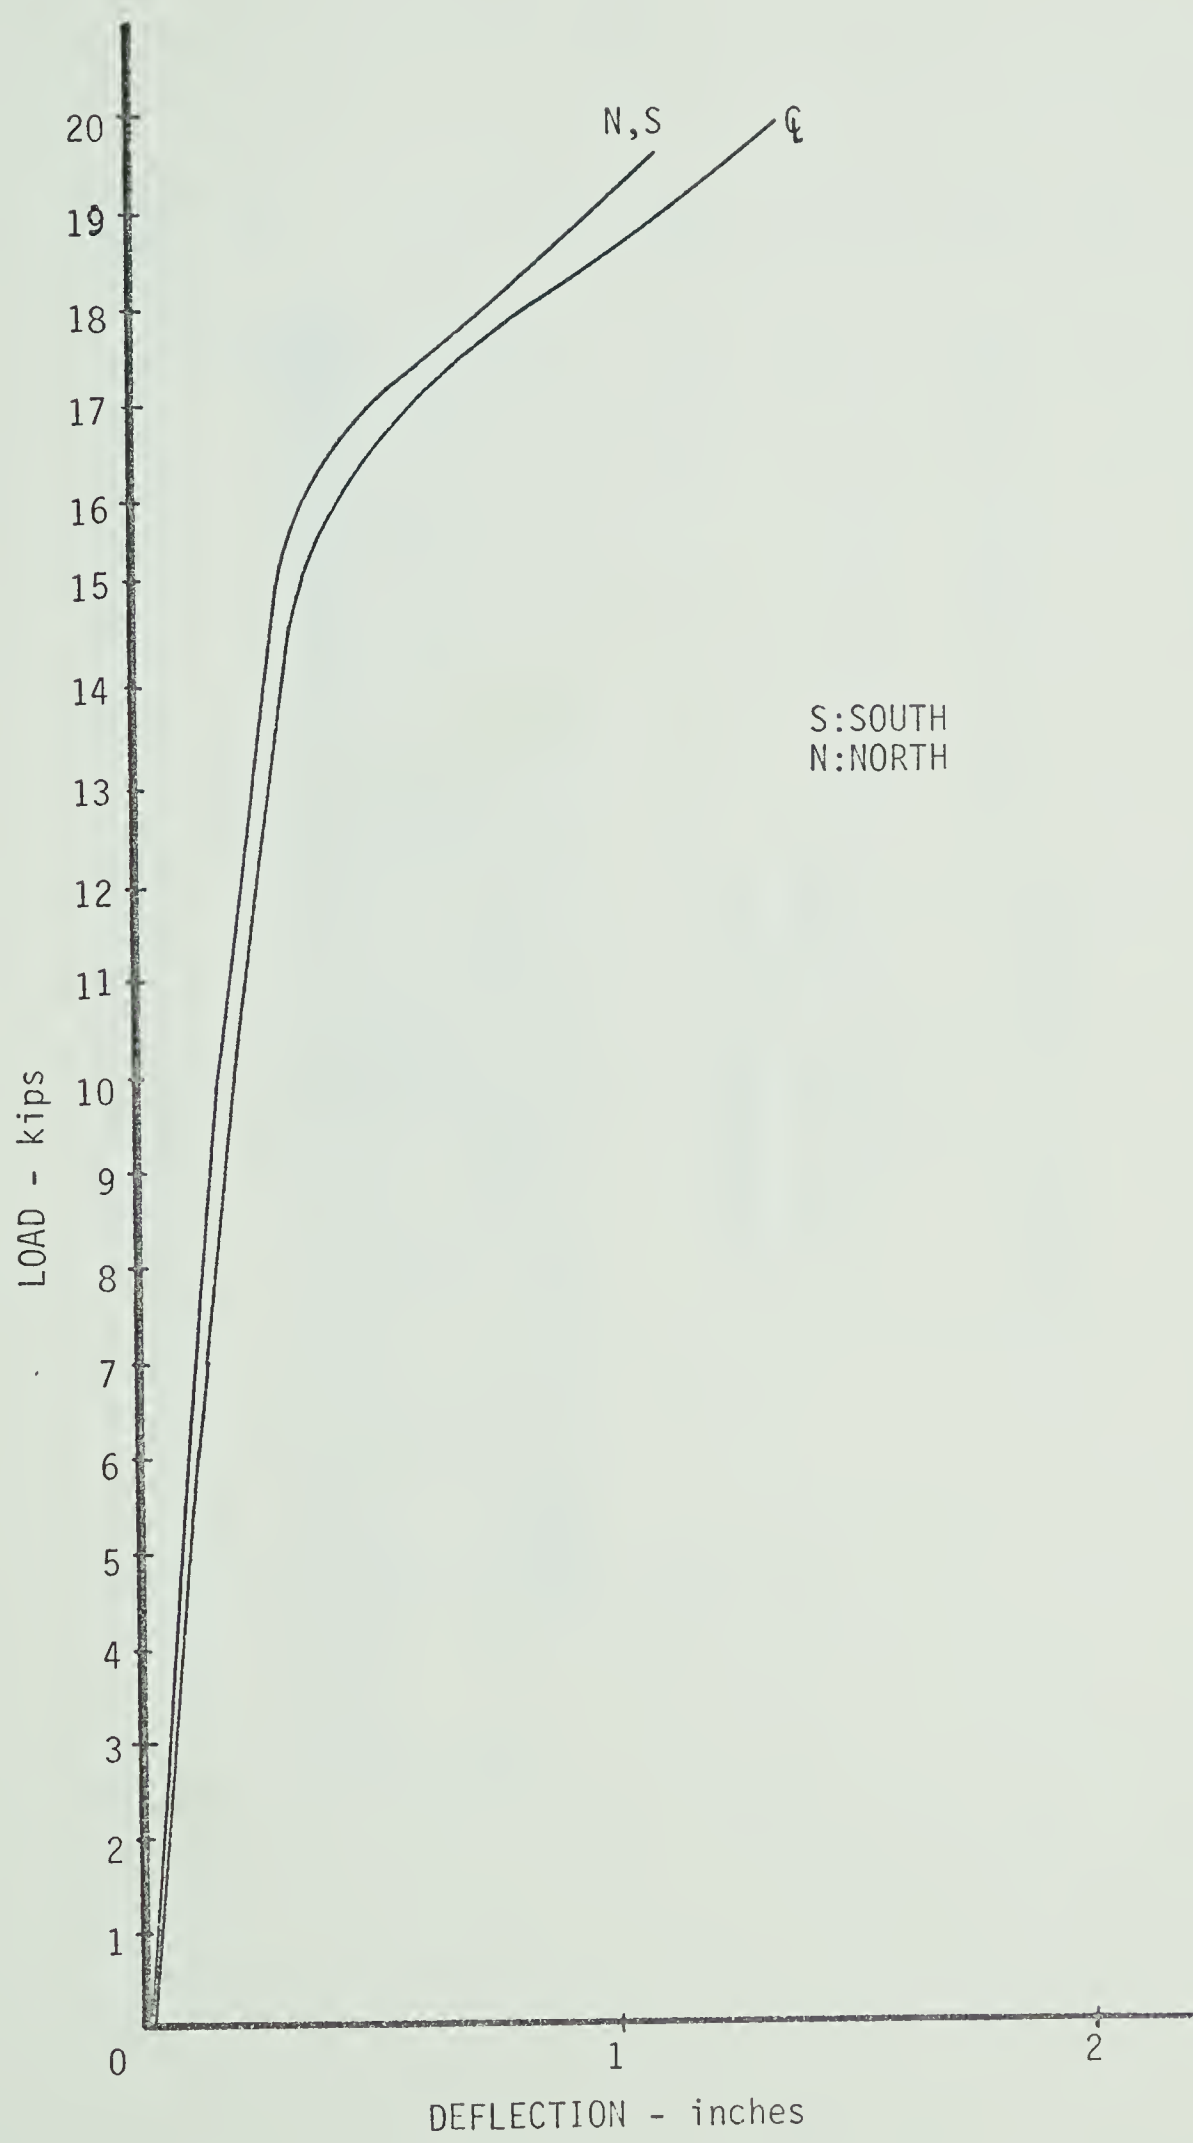
FIGURE B.8.2 LOAD-DEFLECTION DIAGRAM, BEAM #8

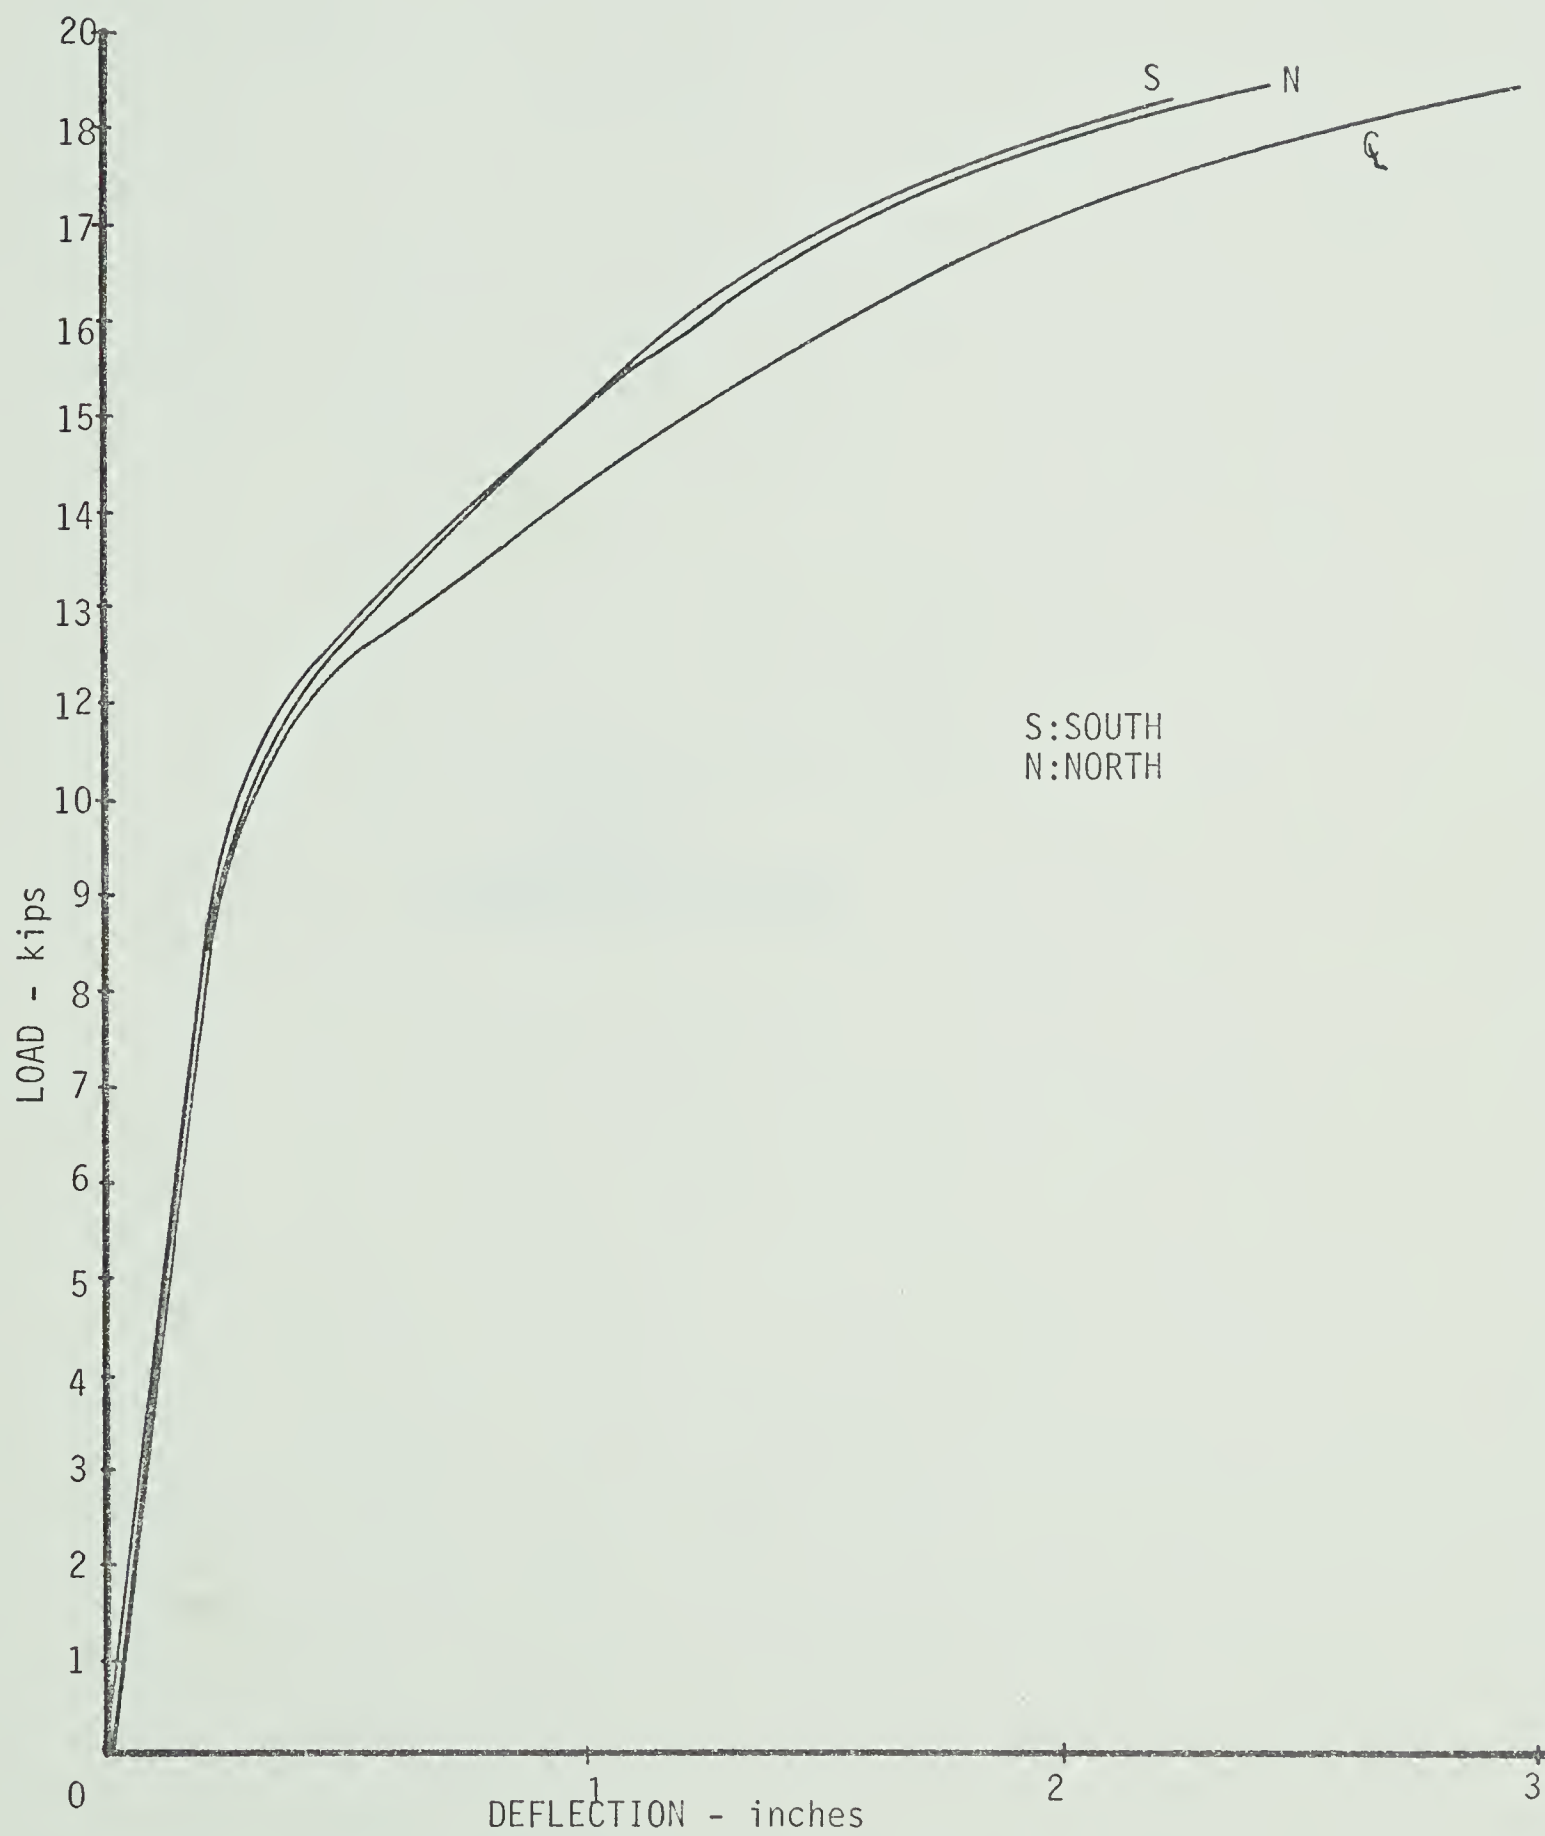
FIGURE B.9.2 LOAD-DEFLECTION DIAGRAM, BEAM # 9
